# FAI Materials Testing Laboratory, Inc.

FAI Project: 1108024

RE: Load testing of one eight foot aluminum balcony section (Juliet)

### Introduction

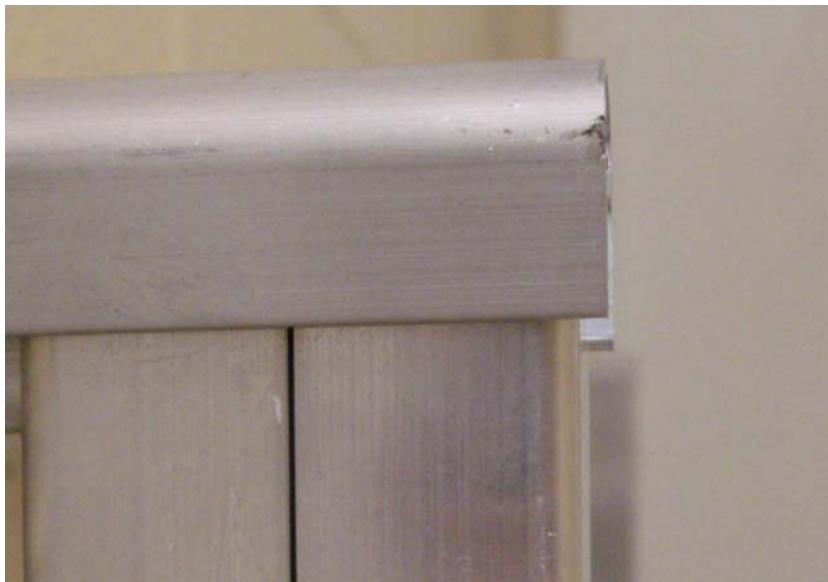
The sample had a slight overhang at the posts at the top of both ends as shown in the Picture 3. Spacers were used between the balcony post and the load frame to avoid over stressing of this overhang. Deflection of the balcony rail was measured at various points along the rail during loading.

**Figure 3: Overhang (typical)**

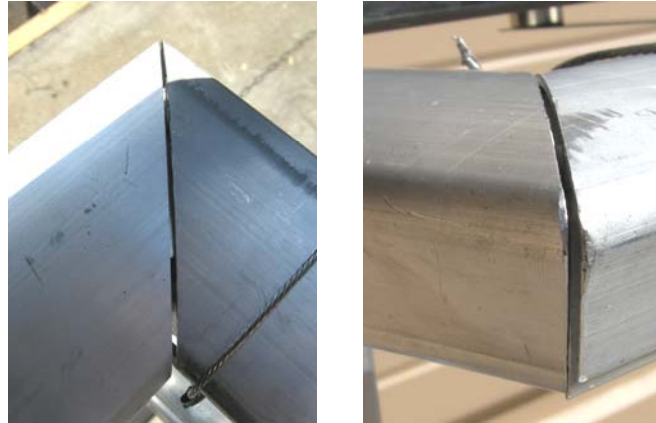
During the horizontal load, a gap was opened in both miters of the top rail as shown in Figure 5. After removal of the load, the top bar itself, which had been deflected, returned to its original position but the gaps in the miters remained.

**Figure 5: Gap at Top Rail Mitered Corners**

During the vertical continuous test loads, the gaps in the miters which were established during the initial horizontal loading flexed open further, then returned to their pre-vertical load states. There was no growth of the gap due to the vertical loading.

After each removal of a load, the section was examined and no permanent deformations were observed. The gaps at the miters, created during the first continuous load test, changed in shape and size during loading but there was no additional growth of the gaps.
