# FAI Materials Testing Laboratory, Inc.

FAI Project: 1108024

RE: Load testing of one eight foot aluminum balcony section (Juliet)

### Introduction

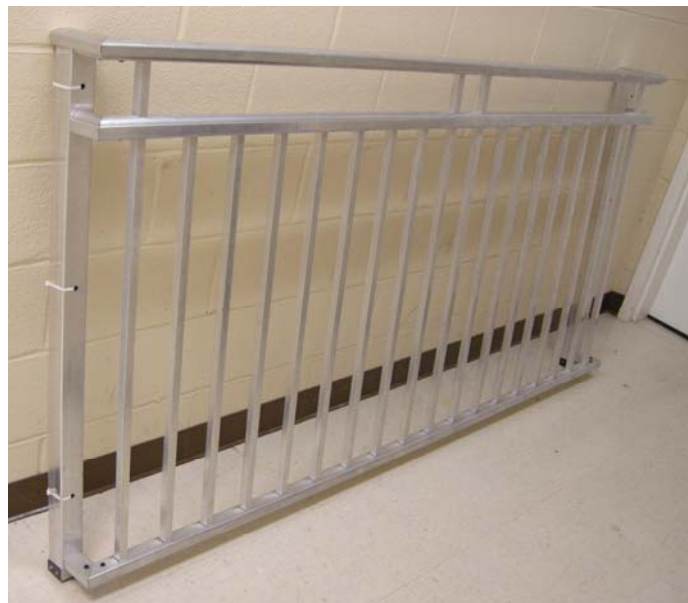
**Figure 1: Section as received**

Snap Tight Aluminum sent FAI a fully assembled balcony section (Figure 1), which FAI mounted with 3/8" bolts onto a steel frame for loading (Figure 2). Loading of the section was made through the use of steel cables and weights.

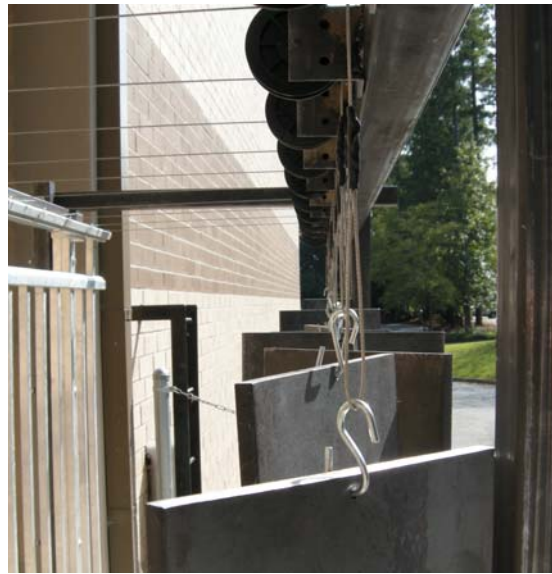
**Figure 4: Loading Direction through Cables and Pulleys**

A linear load was applied by hanging weights from steel cables looped around the top rail of the balcony section. The load was either applied vertically downward directly, or vertically upward or horizontally using mounted pulleys (Figure 4). Deflection of the top rail was measured at the center of the top rail and at multiple points on either side.

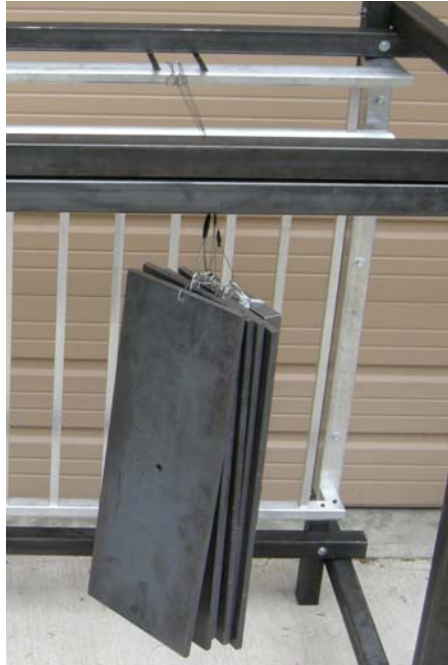
**Figure 6: Concentrated Load Setup (typical)**

A concentrated load was applied by looping steel cables around the top rail and hanging weights or pulling in the desired direction with mounted pulleys. Deflection was measured at the point of stress and other points along the top handrail.

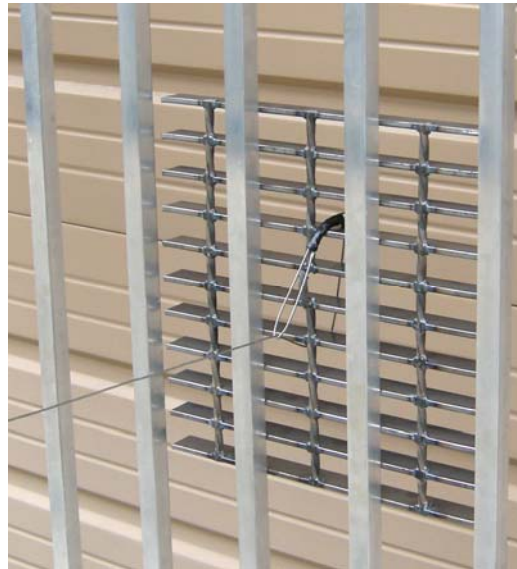
**Figure 7: Uniform 50 lb/sqft load setup (typical)**

A uniform 50 lb per one square foot distributed load was established by using a 1'x1' plate cut from steel grating. During the test, this one square foot area segment bridged two intermediate rails, so that the load was distributed only on these two rails. The load was applied in the center of the fence as well as two other locations two feet from the center on each side.

A deflection during loading was only visible on the two stressed rails. Results of the loading in the three locations are presented in Table 8.
